HOMECHECKR REPORT

REGENT QUAY - PLOT 50

Tuesday, 01 November 2022

4 BEDROOM DETACHED

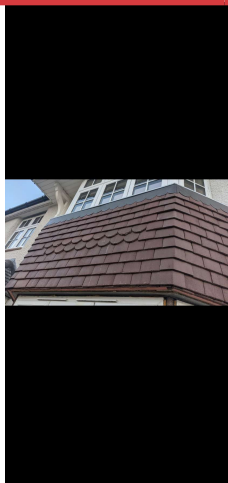
ISSUE 2

Some loose hanging tiles to bay window

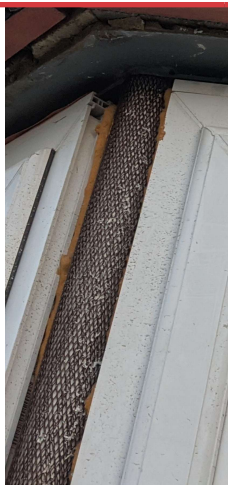
ISSUE 4

Window thresholds do not meet NHBC criteria

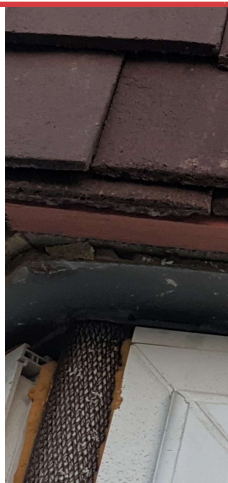
ISSUE 5

Bay window framing not complete

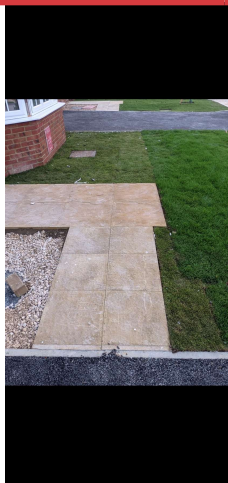
ISSUE 7

Poor workmanship

- Level out stones / need more
- Clean drainage lid
- Remove paint

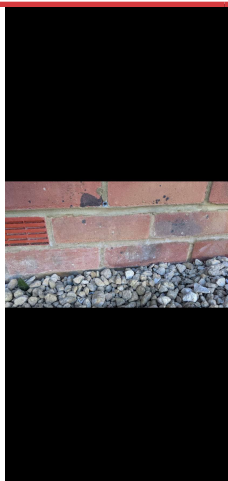
ISSUE 11

Some Weep vents are filled with mortar, these are to be clear of debris allowing moisture to pass through cavity

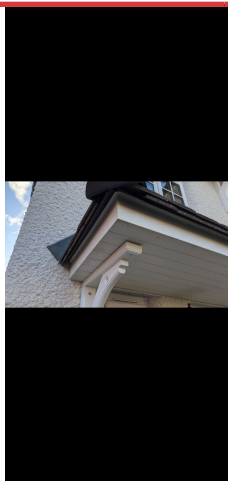
ISSUE 14

Gallow brackets are different colours

Fixing covers missing

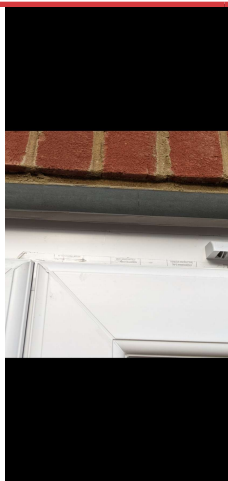
ISSUE 29

Damaged trickle vent

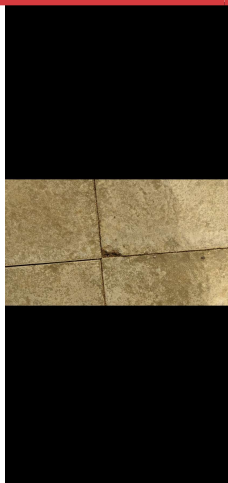
ISSUE 31

Garden slab loose and rocking

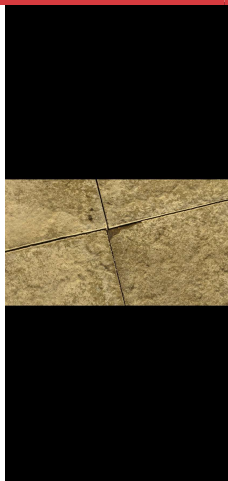
ISSUE 32

Garden slab damage

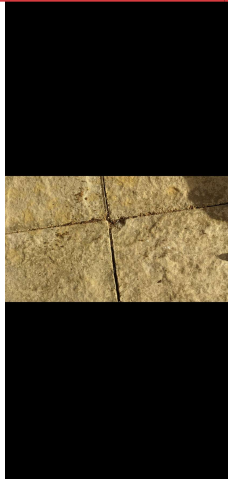
ISSUE 33

Garden slab damage

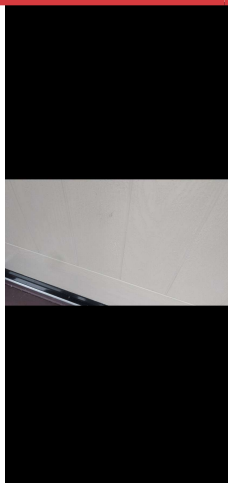
ISSUE 37

Front door poorly painted

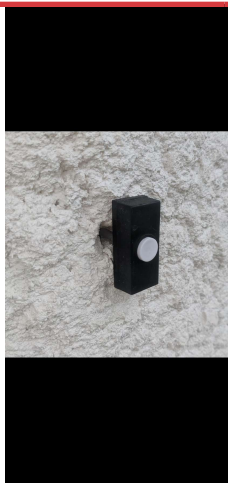
ISSUE 38

Front door damage

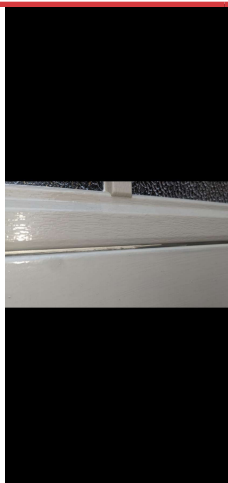
ISSUE 41

Paint on garage door glass

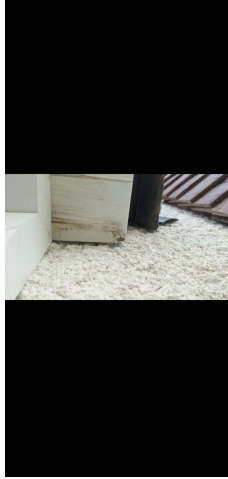
ISSUE 51

Porch damage

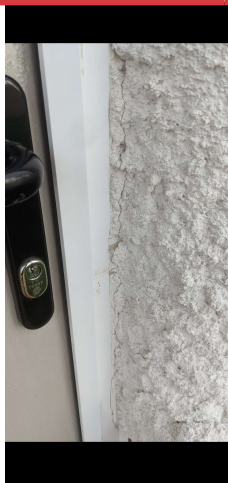
ISSUE 52

Porch damage

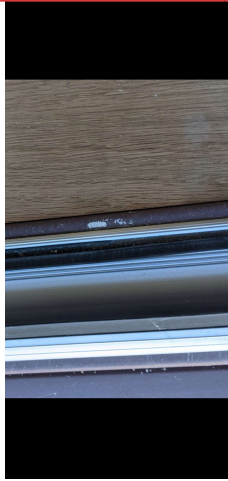
ISSUE 54

Front door seal damage

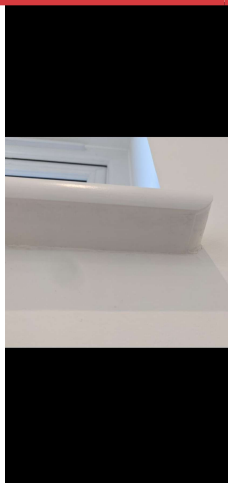
ISSUE 58

Overpaint on window frame

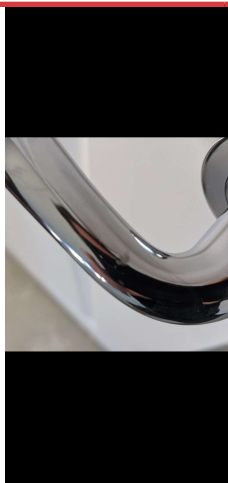
ISSUE 65

Handle damage

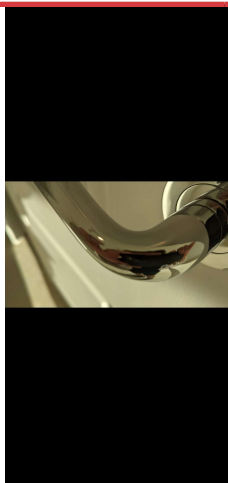
ISSUE 71

Handle damage

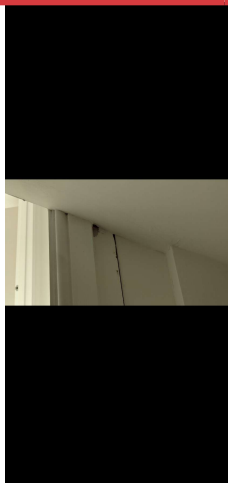
ISSUE 88

Stair timber work damage

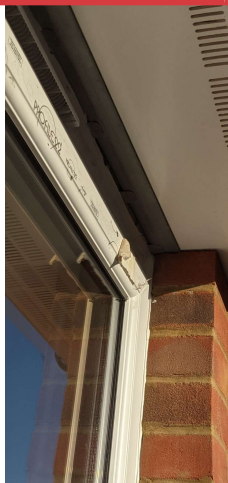
ISSUE 112

Door damage

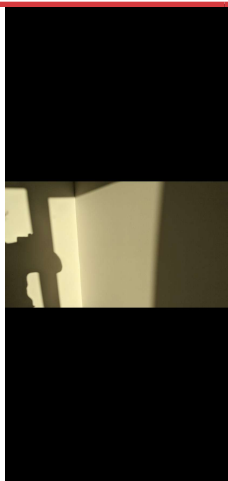
ISSUE 119

Wall damage

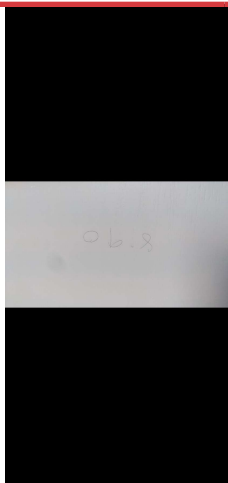
ISSUE 128

Unit door damage

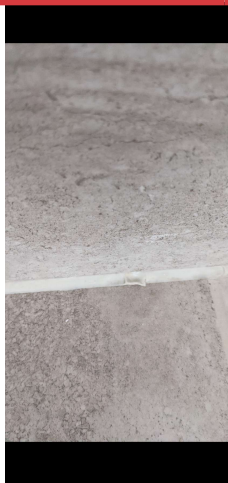
ISSUE 130

Grout missing

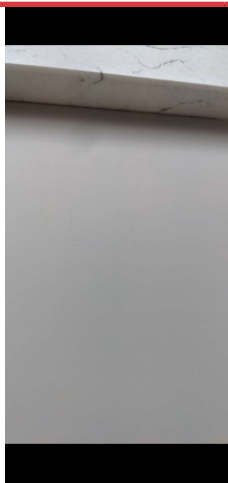
Location Kitchen
Switch damage

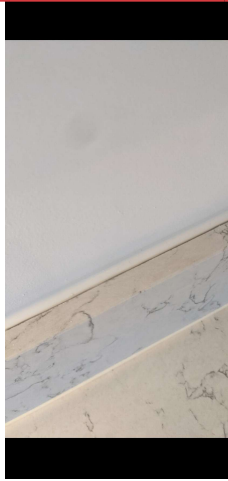
Location Kitchen
Wall damage

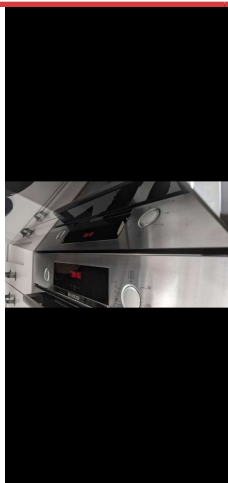
ISSUE 137

Unit Door damage

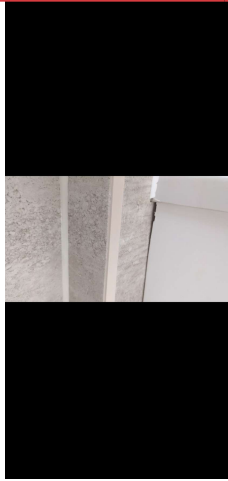
ISSUE 144

Bath panel damage
