HOMECHECKR REPORT

REGENT QUAY - PLOT 50

Tuesday, 01 November 2022

4 BEDROOM DETACHED

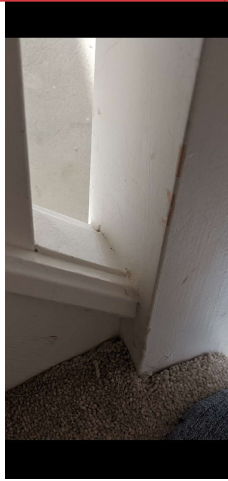
ISSUE 90

Different screws used

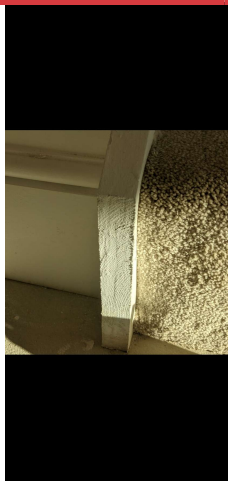
ISSUE 92
Location Staircase
Carpet not fitted correctly
