HOMECHECKR REPORT

REGENT QUAY - PLOT 50

Tuesday, 01 November 2022

4 BEDROOM DETACHED

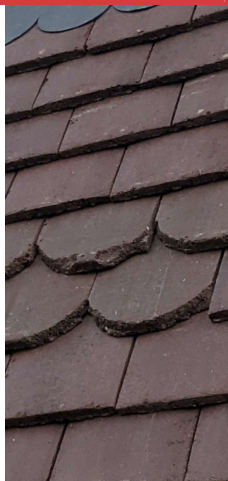
ISSUE 3

Poor workmanship

- Half round hanging tiles poorly cut

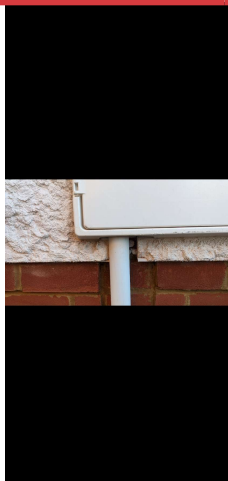
ISSUE 16

Poor workmanship

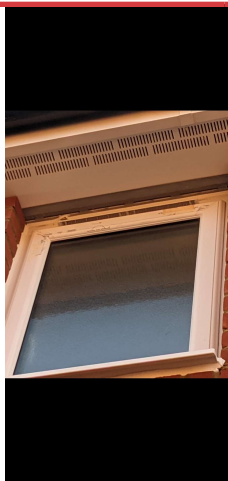
ISSUE 17

Poor workmanship

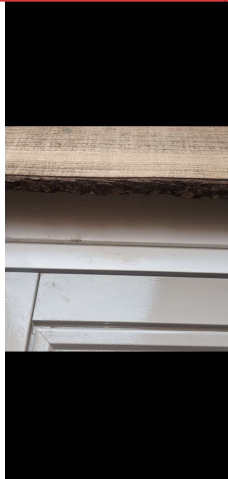
ISSUE 39

Poor workmanship

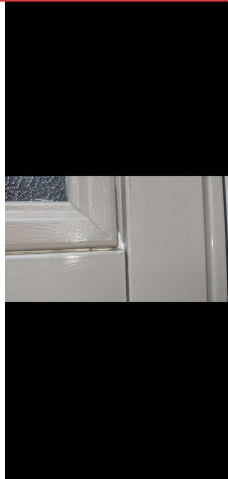
ISSUE 42

Poor workmanship

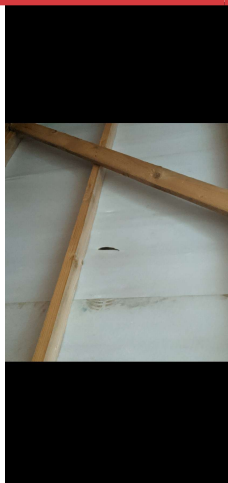
ISSUE 46

Poor workmanship

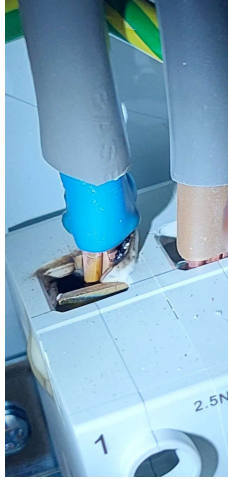
ISSUE 48

Poor workmanship

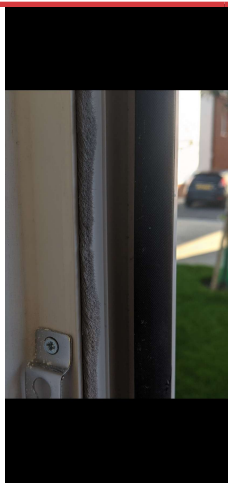
ISSUE 53

Poor workmanship

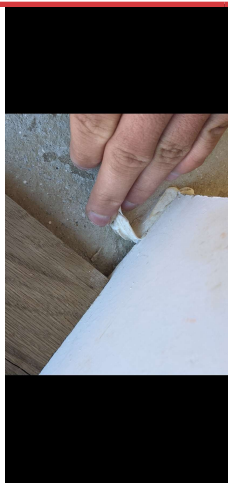
ISSUE 56

Poor workmanship

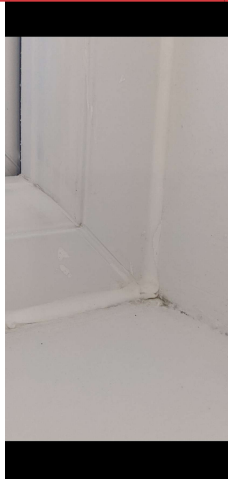
ISSUE 57

Poor workmanship

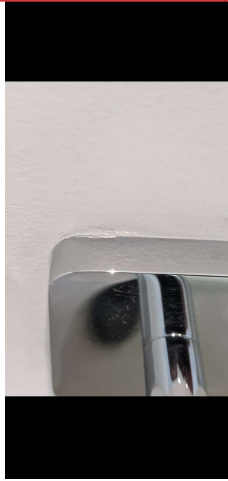
ISSUE 60

Wall not decorated

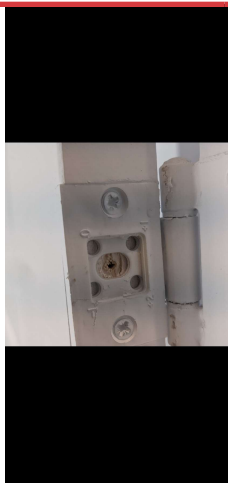
ISSUE 62

Poor workmanship

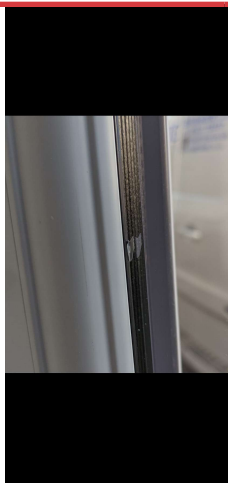
ISSUE 68

Poor workmanship

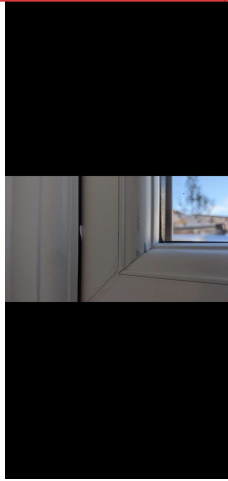
ISSUE 69

Protection film not removed

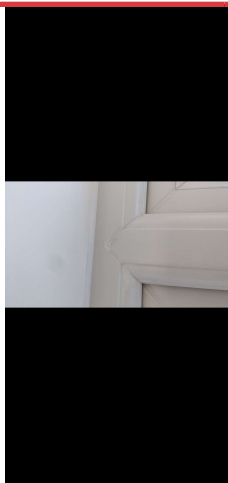
ISSUE 80

Poor workmanship

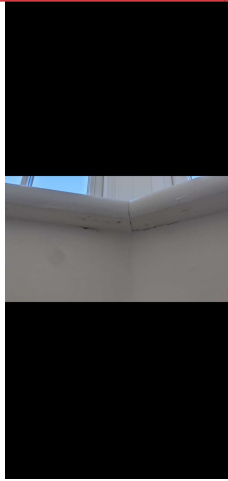
ISSUE 81

Overpaint to window frame

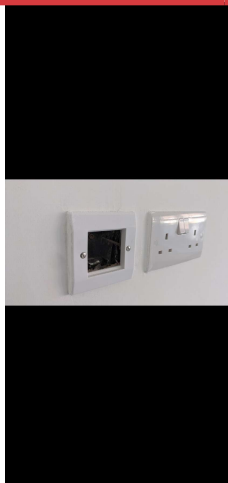
ISSUE 85

Poor workmanship

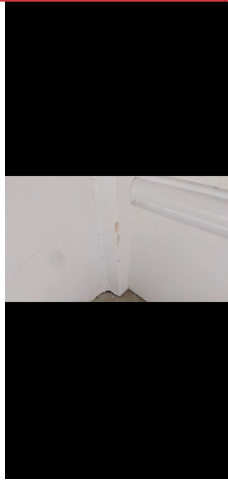
ISSUE 87

Poor workmanship

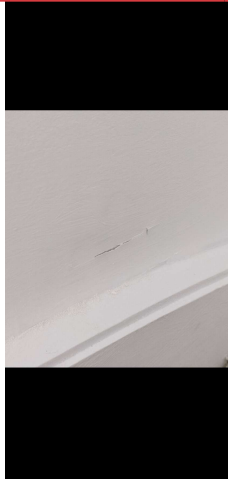
ISSUE 93
Location Staircase
Poor workmanship

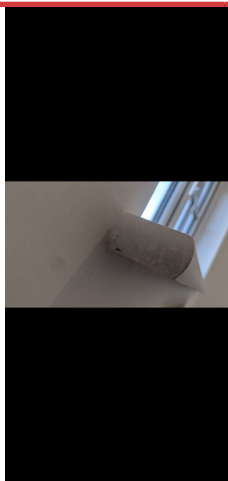
ISSUE 98

Overpaint to handle

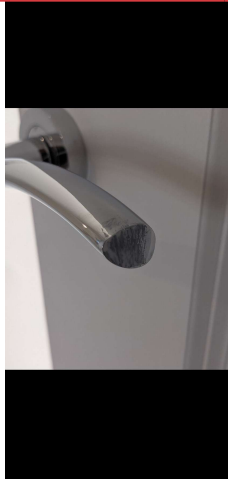
ISSUE 99

Poor workmanship

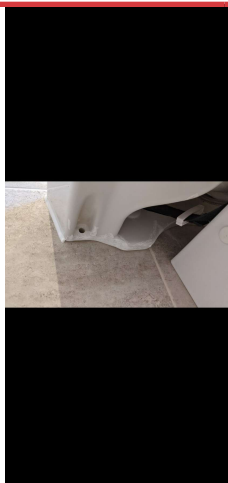
ISSUE 107

- Sink not mechanically fixed
- Overpaint to sink
- Poor workmanship

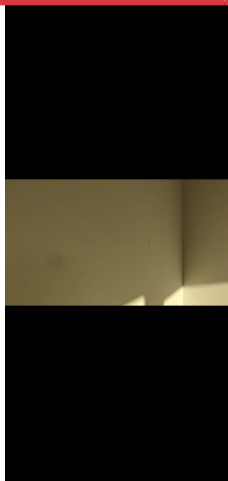
ISSUE 118

Poor workmanship

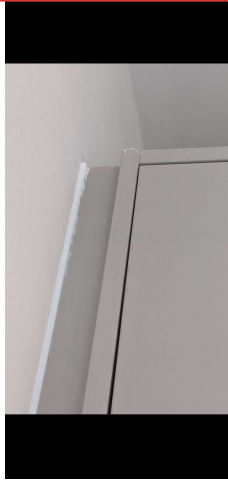
ISSUE 126

Poor workmanship

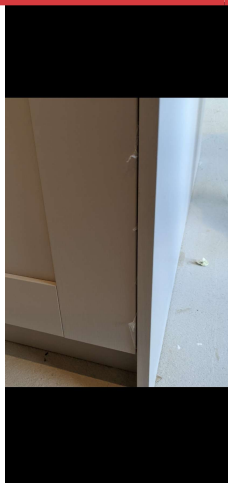
ISSUE 127

Poor workmanship

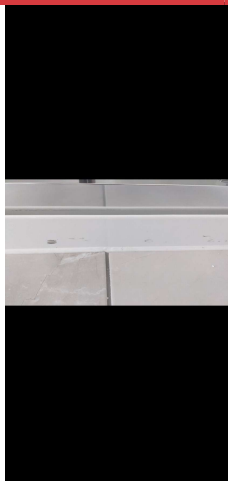
ISSUE 131

Poor workmanship

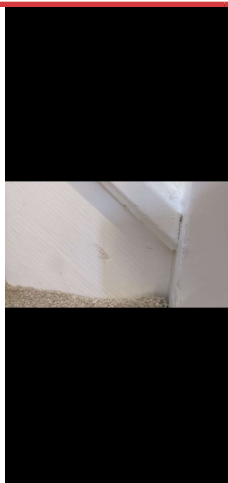
ISSUE 140

Light alignment poor workmanship

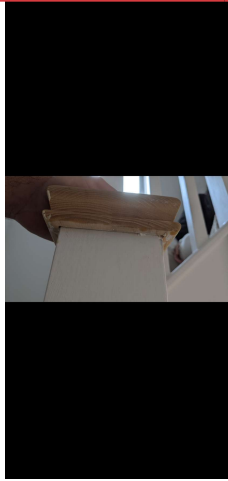
ISSUE 141

Poor workmanship

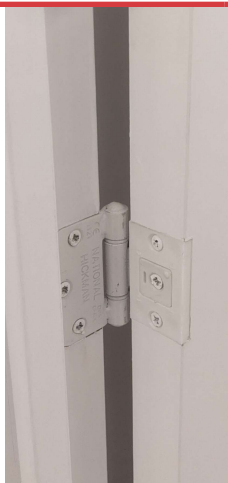
ISSUE 149

Location Kitchen

Poor alignment of doors
